Detailed Visual Inspection

1971 Plymouth Hemi 'Cuda 2 Door Hardtop

V.I.N. BS23R1B295953 Mileage 79,203

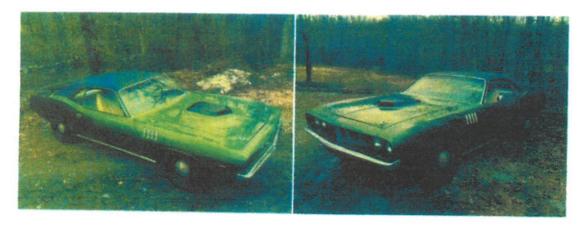
RH front view

LH front view

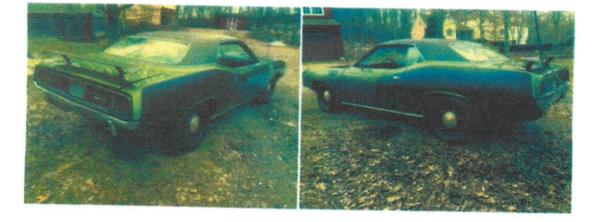
RH rear view

LH rear view

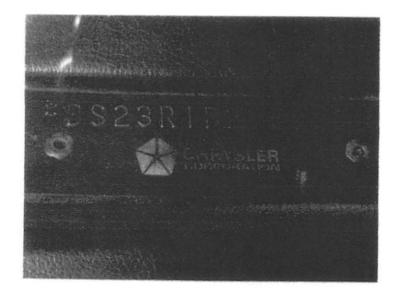
1. Dash VIN - Found on drivers side of dash, visible through the windshield.

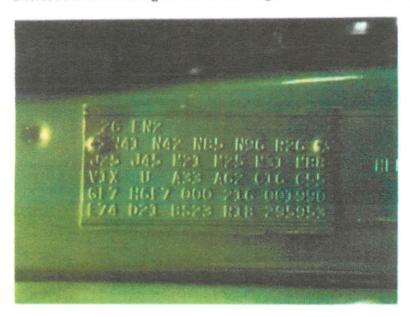
4. Fender tag-found underhood near battery, VIN is on the bottom row of the tag.

Enclosed is a decoding of the fender tag and some related paperwork.

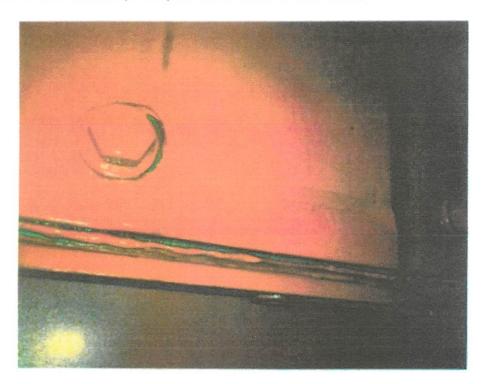
5. VIN is normally stamped on engine pad-found on passenger side lower block. This is a correct unstamped replacement block for this vehicle

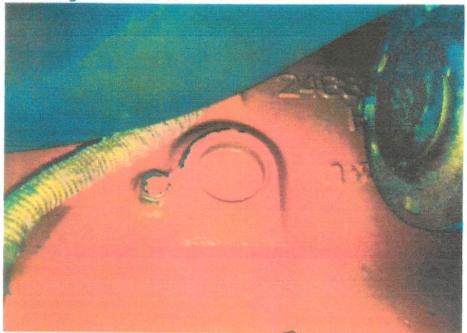
- A. The casting date on a Hemi is on the drivers side of the block, behind the starter.
- B. The casting date is: 7-28-69

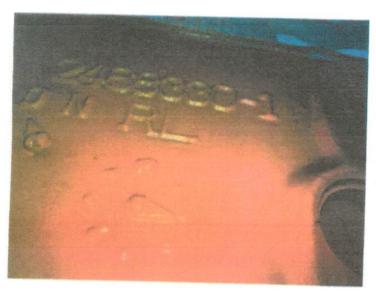
B. Casting Number and clock is found on the passenger side of a Hemi block. The casting number is 2468330-1

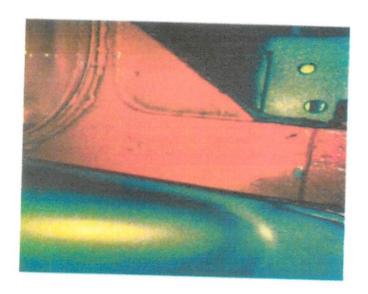
426 CID Hemi. There is also the engine ID stamped on the oil pan rail, below the starter on a Hemi. The meaning to the stamped numbers are NM 426 $\underline{3033}$ 65520 (Nov 16, 1970). THE 426 BLOCK IS AN "RB" ENGINE.

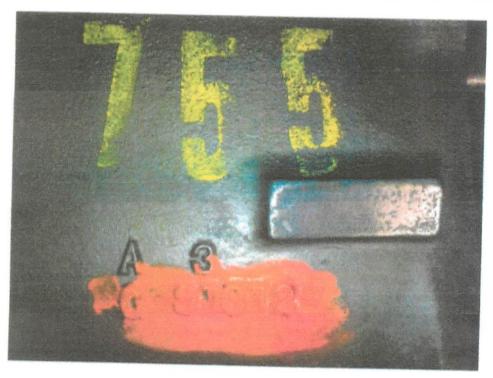
6. VIN is normally stamped on Transmission–found on passenger side of the manual transmission case.

This transmission is the correct part and dated correctly but the VIN on the pad is not legible therefore it can not be determined whether or not this is the original transmission for this car.

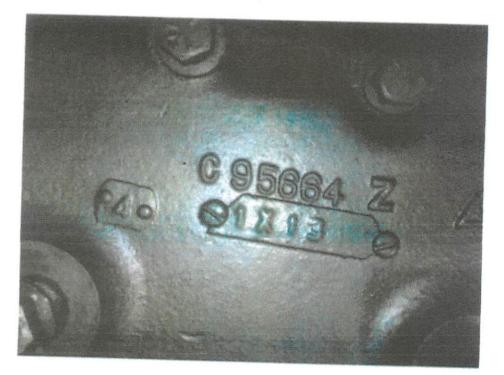
A. Correct factory castings and markings.

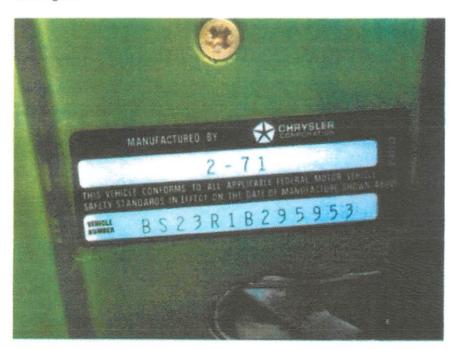
7. Beginning in 1970, there should be a door VIN decal-found on the backside of the drivers door. It will tell the month and year of manufacture. At the B-plant it is mounted horizontally. This decal is a repro of the original.

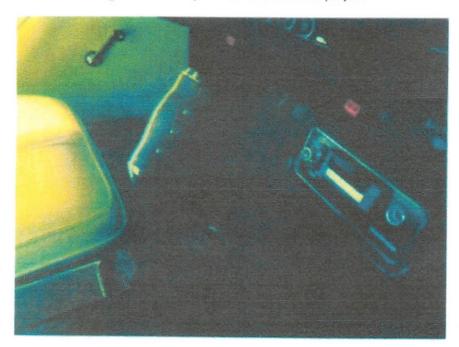
Correct and original Pistol Grip Shifter and cassette player.
