DETAILED VISUAL INSPECTION

DESCRIPTION	
1968 DODGE Super Bee 2 Door Coupe	
V.I.N. <u>W M 2 1 J 8 A 3 0 3 1 5 8</u>	MILEAGE <u>45,941</u>
AREA	CONDITION
01 BODY & PAINT: Top/Bottom: RR1-Burgundy Metallic. Paint is crazing. Water in paint. Hood: Power bulge Stripes: 317-White bumblebee. Radiator support is not black on dark painted cars.	3 of Six
02 CHROME & GLASS: Mouldings/Pot metal: Excellent condition. Solex: All clear>All tinted glass. Side Markers are: Lights only. Outside Mirrors: LH Manual>Remote Chrome.	2 of Six
03 INTERIOR & SEATS: Trim=H4X. Ft Seats=Black Vinyl Bench & headliner. Black dash pad, seat belts & carpet. Rallye Instruments. Steering Wheel: Woodgrain. Radio: AM>AM/FM. Shifter: Floor.	2 of Six
04 ENGINE: Optional 426 cu in, 425 hp Hemi w/2-4bbl Carter AFB Carburetors. Valve Covers: Black wrinkle. PCV: Elbow. Intake manifold: Stock/Aluminum. Exhaust manifolds: Stock/Cast Iron. Air Cleaner: Chrome dome.	2 of Six

Herein is the summary of the visual inspection on the **1968 DODGE Super Bee 2 Door Coupe** VIN **WM21J8A303158**. I did on September 24, 2011 at Masterpiece Classic Cars in Whiteland, IN with the use of a hoist.

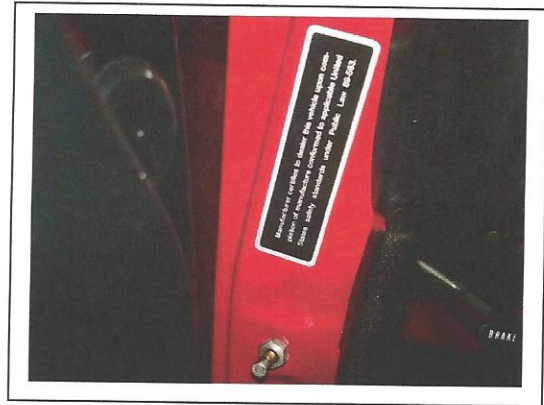
Typical Public law decal.
Front door jamb, above switch.

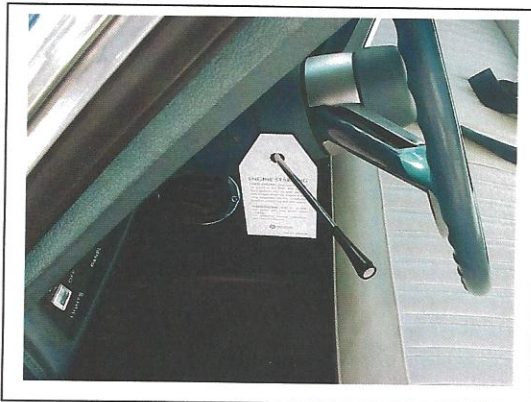
Typical starting Instructions.
On turn signal lever.

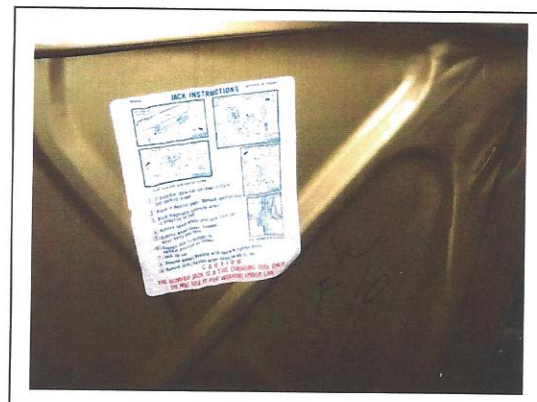
Typical jacking Instructions.
Crayon-Typical of Lynch Road plant.

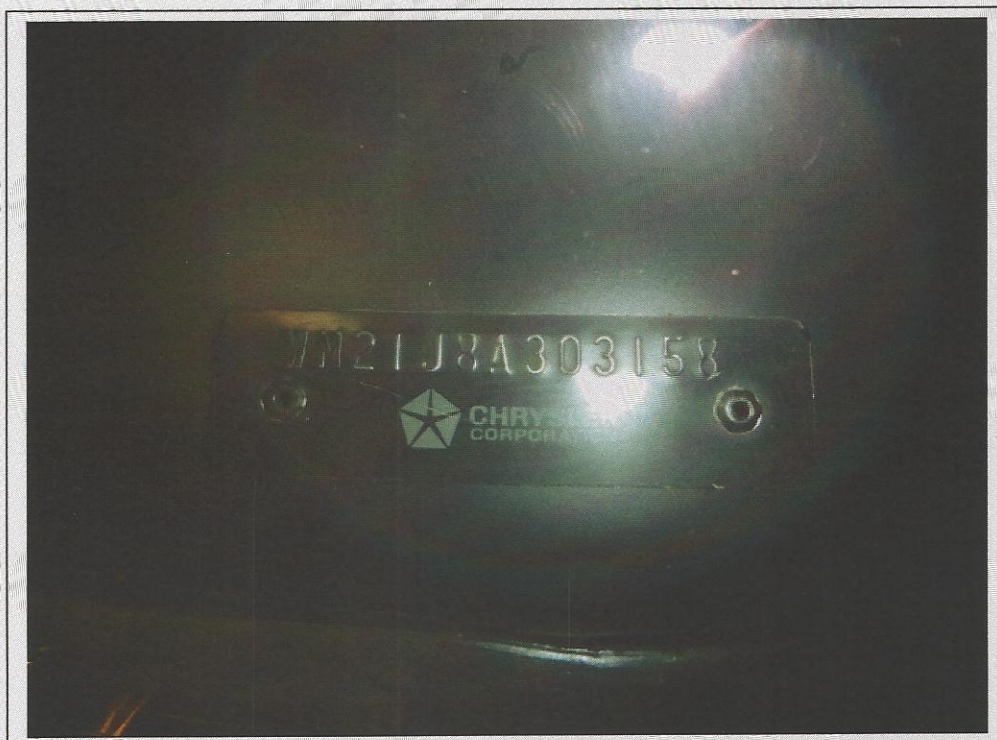
3. Primary body code-typically found on the backside of the radiator support, stamped up-side-down.
 - A. Body code numbers include assembly plant, model year, first digit of VIN and S.O. number.

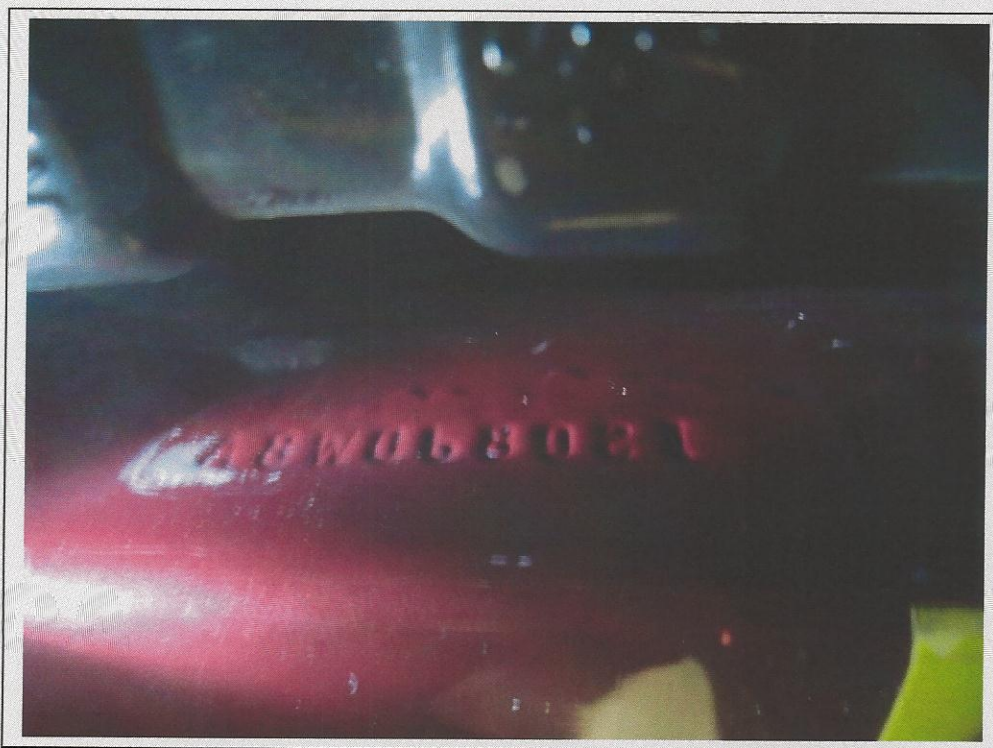
4. Secondary body code-typically found stamped on the drivers' trunk lip, under the rubber weather-strip.
 - A. Body code numbers include assembly plant, model year, first digit of VIN and S.O. number.

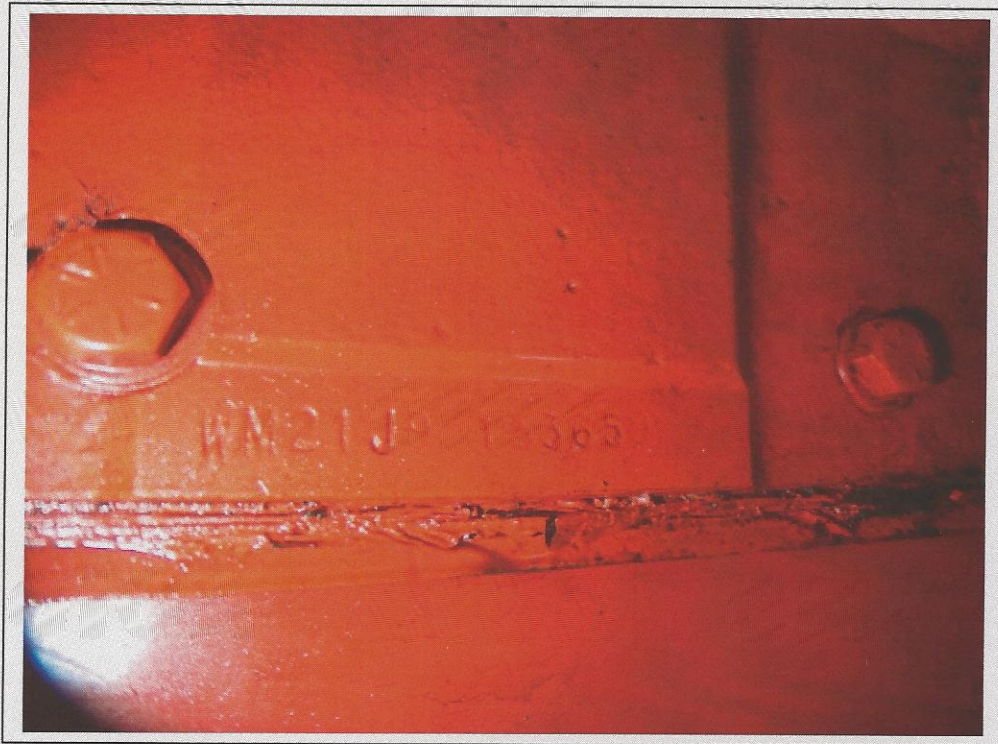
- A. The casting date on a Hemi is on the drivers' side of the engine block, behind the starter.
The casting date is: 3-19-68.

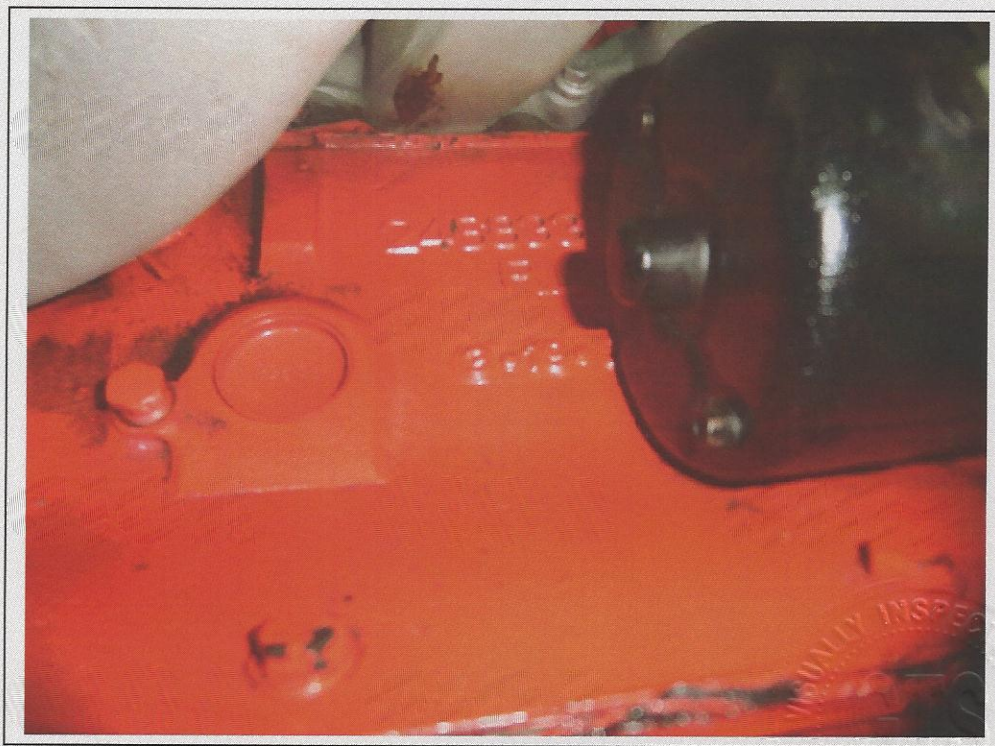
- B. The casting number and clock is found on the passenger side of a Hemi engine block.
The casting number is: 2468330-1.

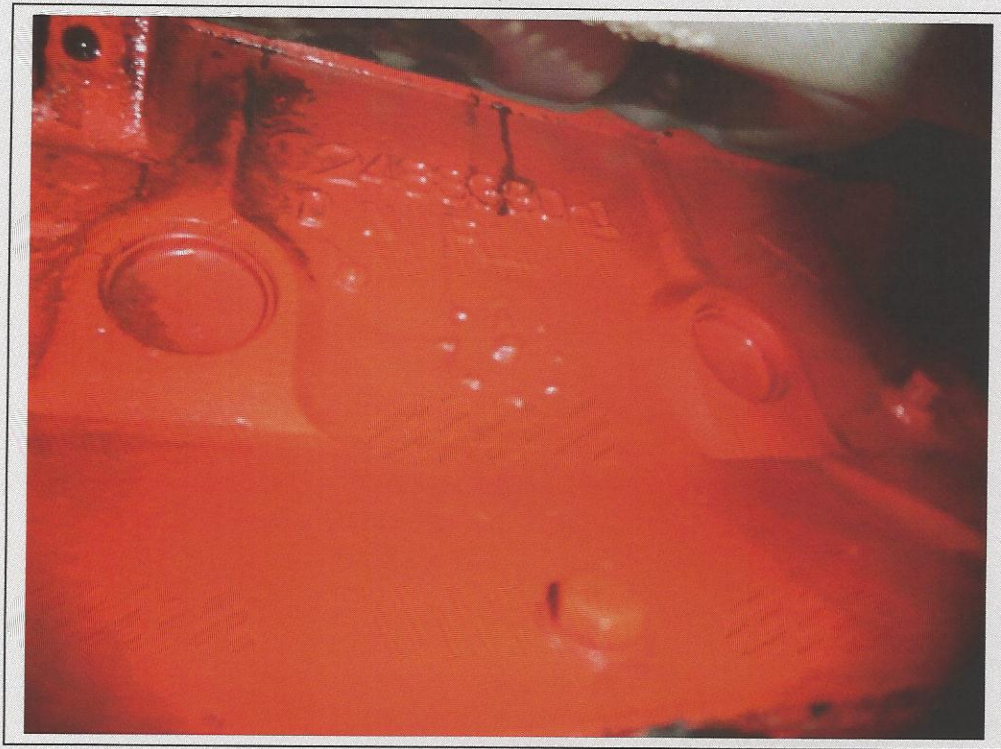
426 CID HEMI. There is also the engine ID stamped on the oil pan rail, below the starter on a Hemi engine block. The meaning to the stamped numbers are E=1969 model year, VN42626216138 (September 30, 1968). THE 426 BLOCK IS AN "RB" ENGINE.
